**ATOMIC FORCE MICROSCOPY (AFM) PHOTO CONDUCTIVE ANALYSIS AND CALCULATION FOR REGULAR AND MENDEZIZED® COMMERCIAL 24 KARATS GOLD BARS CONDUCTED IN FIVE DIFFERENT TRIPLICATE SERIES.**

**Date: June 23, 2016**

## **AFM PHOTO CONDUCTIVE REPORT**

**Requester: Mendezized Metals Corporation**  
**Analysis Date: June 23, 2016**

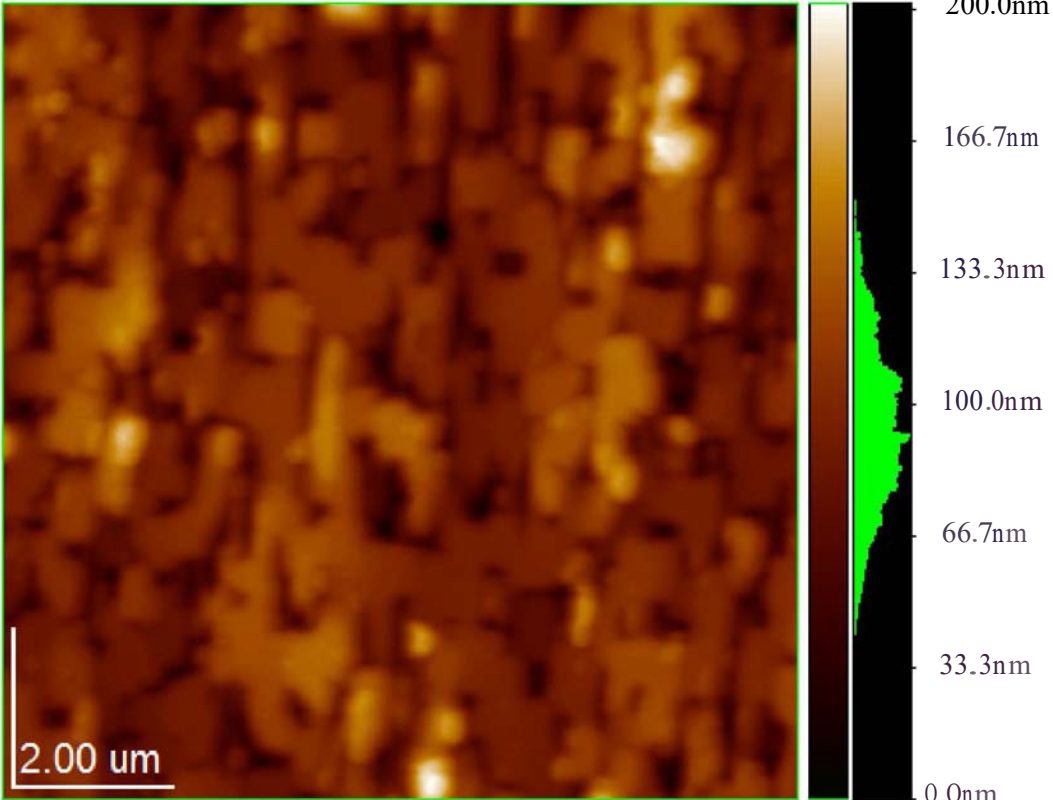
Topography Regular Gold

**Negligible Photocurrent seen in the right image. The image represents several images taken at random locations for data consistency and reproducibility. The topography on the left image is also very rough. Look at the height scale.**

image seems to appear very rough with roughness close to 100 nm. Moreover, the Photo Conductive image for the Credit Suisse commercial gold bar serial number 656079 shows Photo Conductive data which is very typical of this metal. But when the Mendezized commercial gold bar serial number 1001 was investigated under similar conditions, the topography images looks very smooth and the Photo Conductive image is just amazing. The Photo Current was 5 orders of magnitude higher as compared with the Credit Suisse commercial normal gold bar serial number 656079. The Photo Current in the Mendezized commercial gold bar serial number 1001 was so high that we have to put a limiting resistor to avoid any hardware electronics breakdown in the head of the AFM scanner. The Photo Current scientific data and Photo Conductive Images shown below clearly indicate the highly conducting nature of the Mendezized commercial Gold Bar serial number 1001.

**Results:** Mendezized Commercial 24 Karats Gold Bar serial number 1001 have an incredible high Photo Conductivity and Photo Current of almost 500 Milli amperes and 8.4 Volts and the atoms are almost completely flat which doesn't happen with regular commercial Credit Suisse 24 Karats Commercial Gold Bar serial number 656079 that have a very negligible 350 Pico amperes and almost 0 Volts and the atoms are 33.3 nanometers in high.

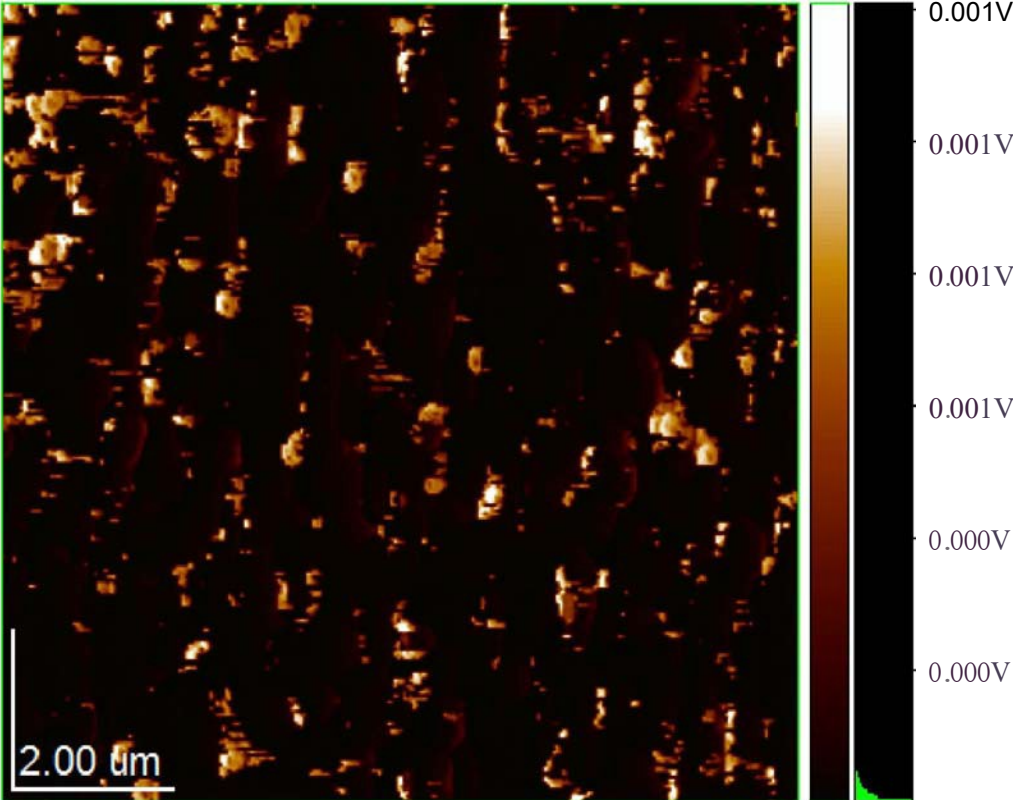
Photo Current  
Image of Regular  
Gold Bar. 0.0 Volts  
and 350 Picoamps.

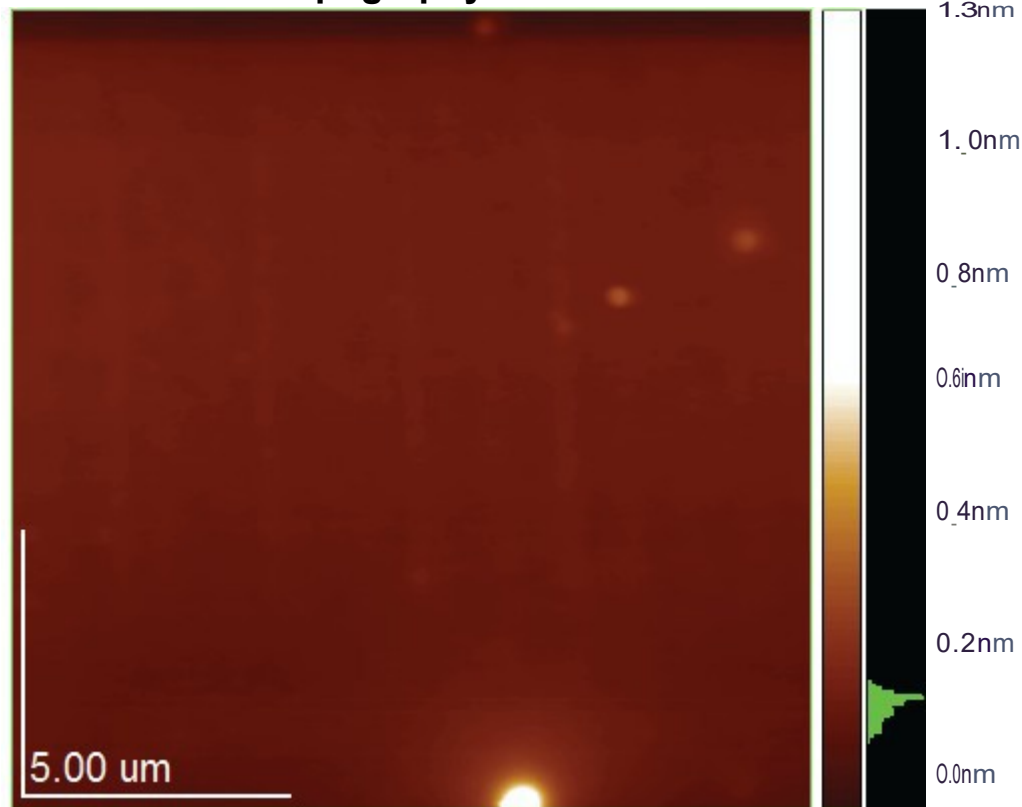
Topography Mendezized Gold Bar / Atoms are almost completely flat.

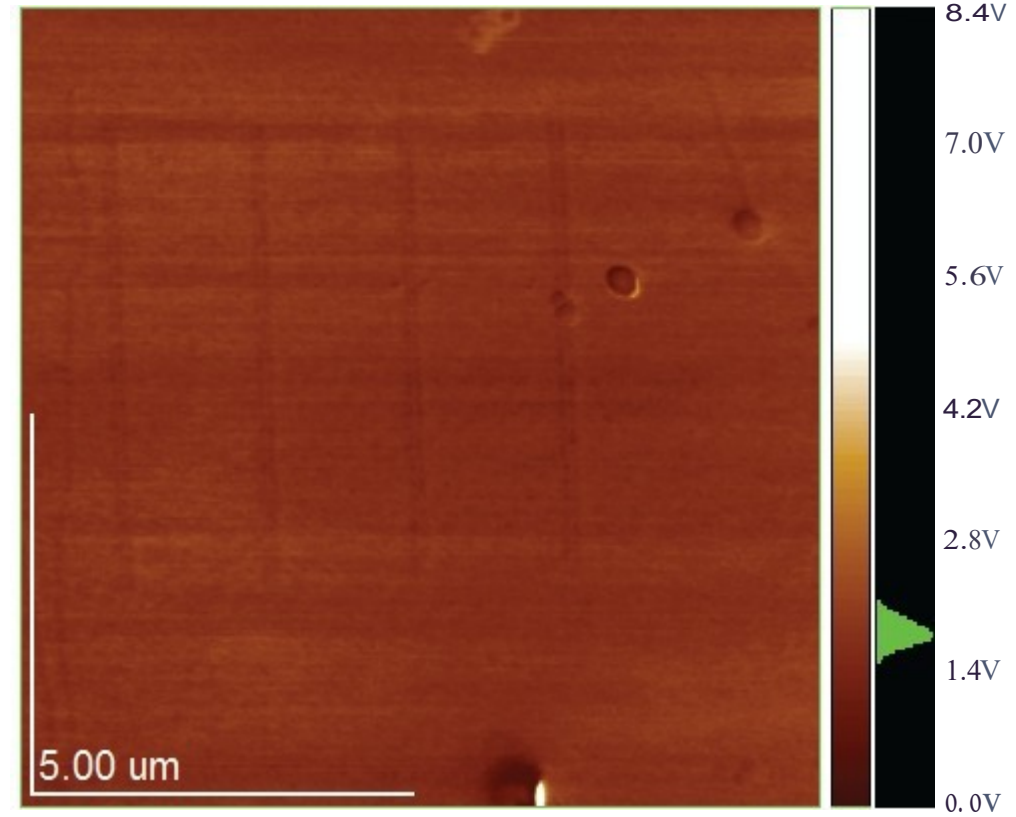
Photo Current Image of Mendezized Gold Bar / Almost 500 Milli amperes and 8.4 Volts per each 30 nanometers areas.

**Massive Photocurrent seen in the right image. The image represents several images taken at random locations for data consistency and reproducibility**
